PCN #		Issued Date	
2026001		01/12/2025	
PCN Title			
Amphenol Right-Angle M8 GPIO Cable Notice.			
Document Version		Customer Contact	
1.0		Sales@thinklucid.com	
PCN TYPE	<input type="checkbox"/> Electrical Specification	<input type="checkbox"/> Regulatory or Compliance	
	<input checked="" type="checkbox"/> Mechanical Specification	<input type="checkbox"/> Part Number Change	
	<input type="checkbox"/> Optical Specification	<input type="checkbox"/> End of Life	
	<input type="checkbox"/> Firmware Specification	<input type="checkbox"/> Other	
Affected Part Number(S)			
PART NUMBER		DESCRIPTION	
GPIO-M8-5M-RA1-A		Amphenol M8-Open GPIO IP67 Cable 5M (RA1)	
GPIO-M8-5M-RA2-A		Amphenol M8-Open GPIO IP67 Cable 5M (RA2)	
GPIO-M8-15M-RA1-A		Amphenol M8-Open GPIO IP67 Cable 15M (RA1)	
GPIO-M8-15M-RA2-A		Amphenol M8-Open GPIO IP67 Cable 15M (RA2)

Reason and Description of the Product Change

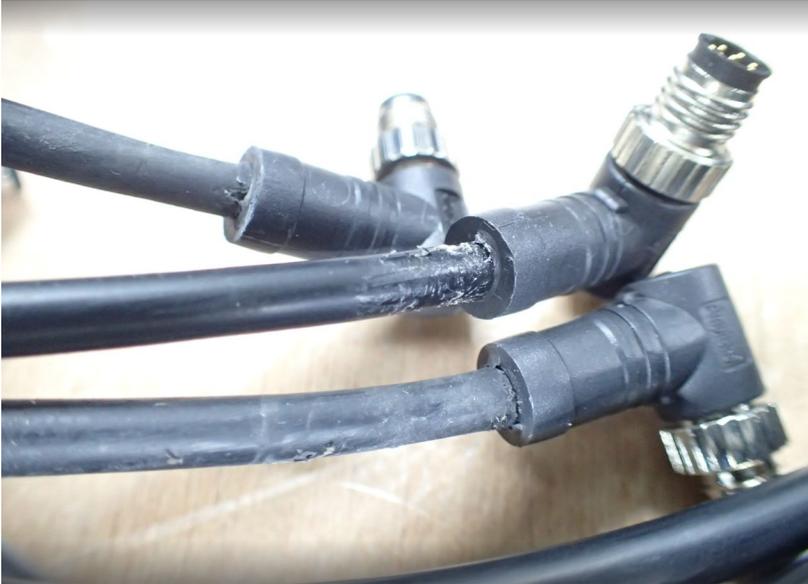
Adhesive Residue:

A nonconformance was reported involving adhesive residue on right-angled M8 cables, with some units exhibiting nonconforming M8 overmolding.

The issues have been escalated to the supplier. The root cause of the adhesive residue was identified as over-application of the clear adhesion primer. The primer's main components are mixed xylenes and methyl isobutyl ketone (MIBK). The defective M8 overmold was caused by incorrect settings on the molding machine.

Upon further review, the supplier confirmed that neither the adhesive residue nor the defective M8 overmold has any functional impact on the cables, as all units undergo functional testing for proper signal transmission and leak testing prior to shipment.

- The brush used to apply the primer has been replaced with a finer brush.
- Changes applied to cables manufactured on or after 12/10/2025.

If you have cables exhibiting the adhesive residue or defective M8 overmold issue, please contact LUCID [Support](#) to request for replacement cable free of charge.
